U. S. NAVAL PROVING GROUND DAHLGREN, VIRGINIA

REPORT NO. 1180

WEAPON "A" LAUNCHER CHANGES

ROCKET LAUNCHER MARK 19 MOD 0 PROOF FIRING TEST OF PRODUCTION MODEL

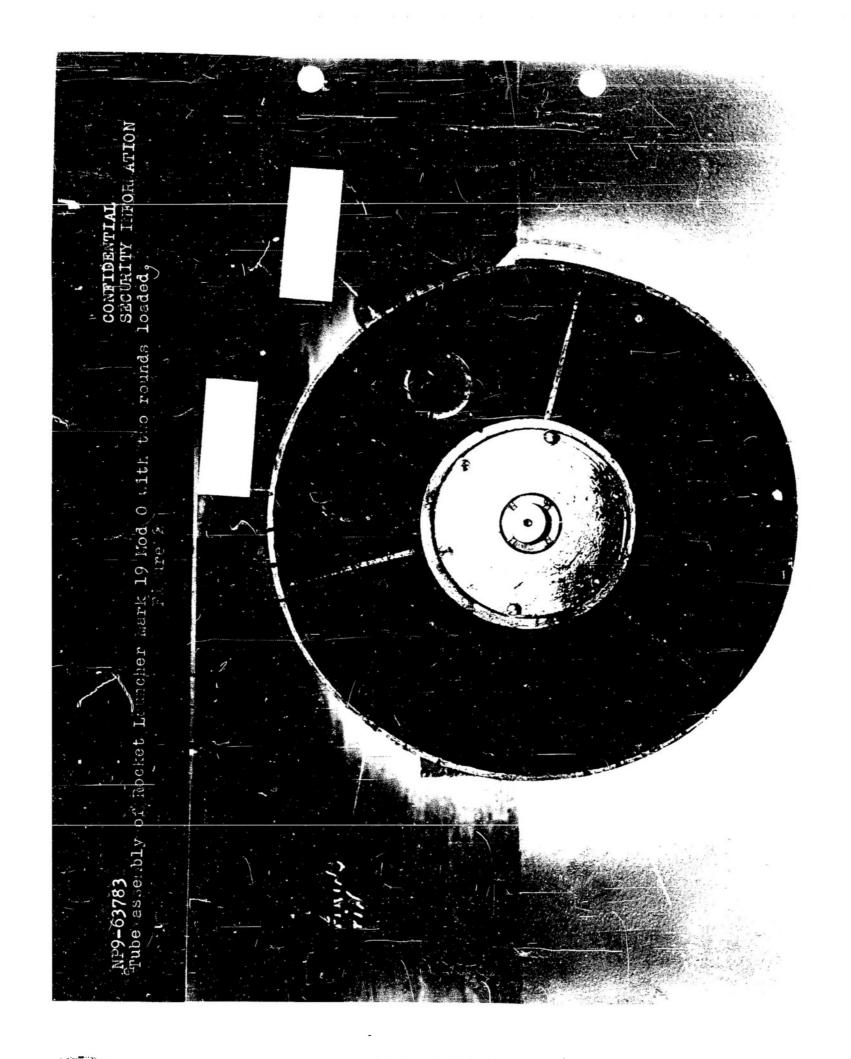
- a. The Rocket Launcher Mark 19 Mod 0 is a sub-caliber attachment designed to adapt the Rocket Launcher Mark 108 to the firing of 4.0 Sub-Caliber Rockets in anti-submarine practice. The launcher consists of two principal components, a tube assembly and a spacer assembly, as shown in Figure 1. The complete launcher assembly is inserted in the guide tube of the Rocket Launcher Mark 108. It is sub-divided to hold six (6) 4.0 sub-caliber rockets, as shown in Figure 2. The assembled round is shown in Figure 3. When properly energized, an electrical firing mechanism (Figures 2 and 4), contained in the tube assembly, fires the rockets in sequence. The operation of the firing mechanism is explained in Appendix (C). The Rocket Launcher Mark 108 operates in a normal manner with the Mark 19 Launcher inserted in the guide tube. The director controls elevation and train and the local mount operator fires the rounds.

tube and spacer assembl

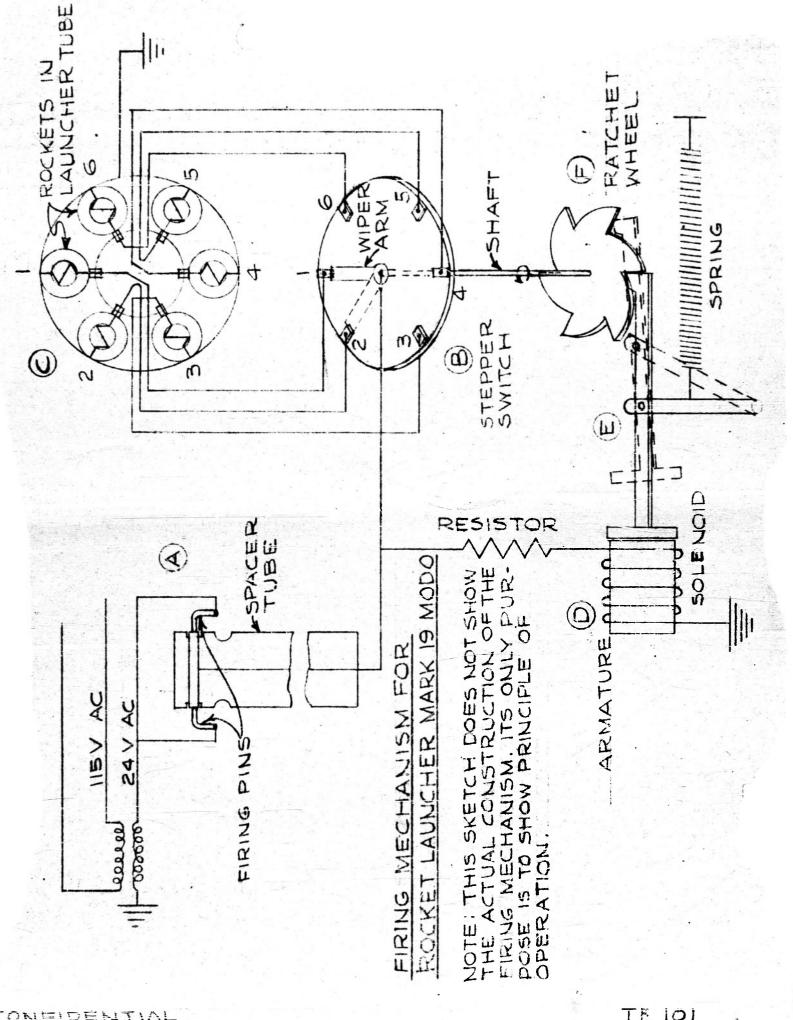
(Figure 7)

In each case where dual firing occurred only a single firing pin was contacting the spacer tube. The dual firing encountered always occurred on rounds positioned in the same sector of the launcher tube as the firing pin. With two firing pins contacting the spacer tube one of the firing pins in the same sector as the rounds being fired may be lifted. However the other firing pin, diametrically opposite, is not affected and maintains a constant voltage supply to the firing mechanism. This assures proper functioning of the firing mechanism and fires the rounds in their proper sequence.

FIRING MECHANISM FOR ROCKET LAUNCHER MARK 19 MOD 0; PRINCIPLE OF OPERATION

The firing mechanism is contained in a cylindrical tube approximately 3" in clameter and 24" long that is fitted inside the center of the Mark 19 Launcher tube at the after end. It is energized from the firing pins of the Rocket Launcher Mark 108. The six (6) firing pins of the Rocket Launcher Mark 19 are individually connected to the contacts of a "stepper switch". The "stepper switch" consists of six equally spaced contacts arranged in a circle around a wiper arm connected to the firing circuit. The wiper arm is rotated by a shaft operated by a solenoid and ratchet gear. Figure 7 shows the stepper switch set to fire round 1. When the firing circuit is closed, 20 volts AC flows through the Mark 108 firing pins to the contact band of the spacer tube (A). The spacer tube conducts the current to the firing mechanism. The current flows through the wiper arm to the No. 1 contact of the stepper switch (B), to No. 1 firing pin (C) to fire No. 1 round, and to the ground return. At the same time the current flows through a resistor and energizes solenoid (D). The solenoid attracts the armature, stretches the spring and sets up the ratchet wheel for a cycle. When the firing circuit is released by the operator the armature is released and the spring rotates the ratchet wheel (F) 1/6 of a turn moving the wiper arm to contact No. 2. When the firing circuit is closed for the second time round No. 2 is fired. Each time the firing circuit is opened and closed the cycle is repeated, firing the proper round in sequence.

At the instant of firing the firing circuit remains closed. With only one firing pin touching the contact band of the spacer tube the blast and shock lifts the pin for an instant. This interrupts the current to the solenoid causing the ratchet wheel to cycle carrying the wiper arm to the succeeding position. When the firing pin settles back in position current again flows through the stepper switch and the succeeding round is fired. Thus two adjacent rounds are fired with a single closing of the firing circuit. When both firing pins of the Mark 108 Launcher are touching the contact band of the spacer tube, at least one pin is always making contact and the firing mechanism functions properly.

- a. The Rocket Launcher Mark 108 be trained 35° off the centerline before loading the Rocket Launcher Mark 19 Mod 0 into the guide tube.
- b. Prior to starting a firing program the firing pins of the Mark 108 Launcher should be checked to see that they are contacting the contact band on the spacer tube of the loaded Mark 19 Launcher.
- c. The experimental 400 Sub-Caliber Rockets be modified to improve their flight and decrease their dispersion.
